DETERIORATION OF CALCIA-STABILIZED ZIRCONIA

By John D. Buckley

Langley Research Center Langley Station, Hampton, Va.

TECHNICAL NOTE D-1595

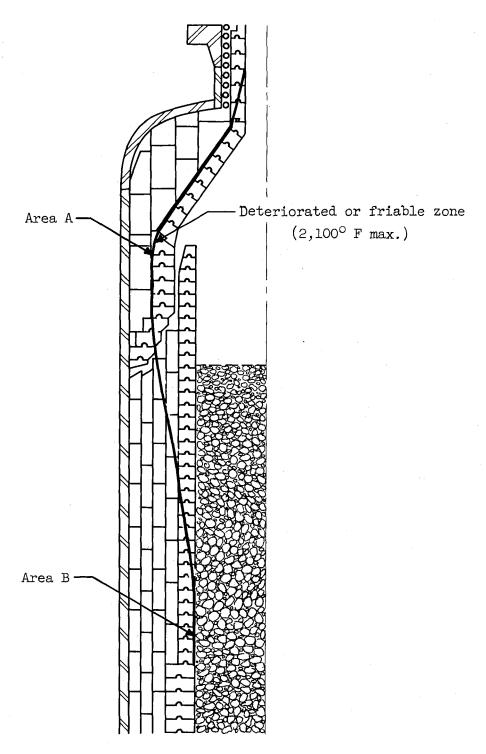
Deterioration, or physical breakdown of the refractory brick to a crumbled powder or friable state, occurred within a narrow annular band 1 or 2 inches wide in the heat-exchanger lining at various depths. The deteriorated refractory material represented by the heavy line in figure 2 and deformed pebbles located in the zone where the line emerged to the hot face of the liner (area B in fig. 2) were subject to cyclic heating never exceeding a maximum temperature of approximately 2,100° F. The thermal line in figure 2 was obtained by monitoring thermocouples, located in various positions in the ceramic liner, during normal operation.

Early in the course of this investigation it was observed that in all instances zirconia refractory in the deteriorated zones of the gas-fired ceramic heat exchanger (fig. 2) had a tan or orange-red color as compared with the light orange or buff color of unused stabilized zirconia. Although the deterioration observed in the ceramic lining of the heat exchanger was reproduced in the laboratory kiln, no color change was observed.

Figure 2.- Sketch showing location of zone of deterioration in the ceramic heat exchanger.

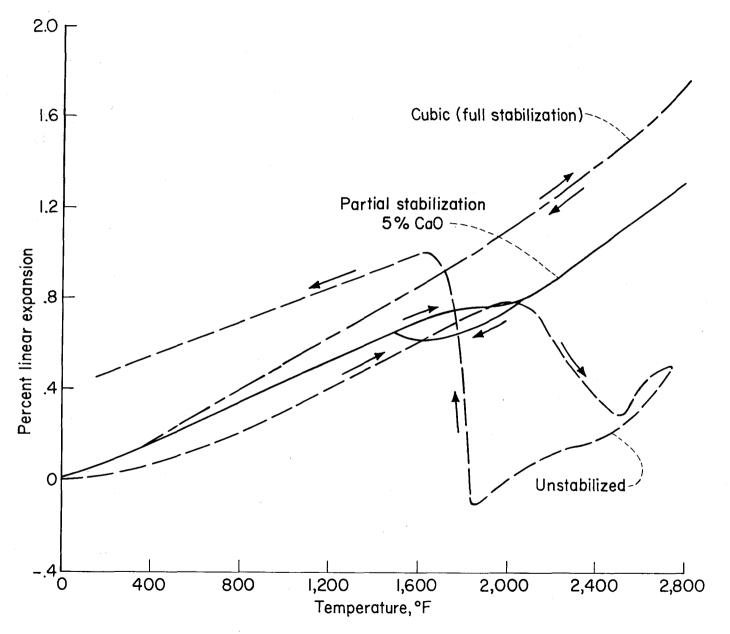
Figure 3.- Thermal expansion of zirconia having various degrees of stabilization as a function of temperature. From reference 2.

although the percentage of calcia differed by less than 0.1 from the original calcia content. The primary purpose of this investigation was to correlate visible deterioration and color variation with change in crystal structure due to cyclic heating in a specified temperature zone. Stabilization data listed in table III indicate that the region of variation in the thermal expansion of partially stabilized zirconia may extend over a broader temperature range than the generally recognized range of 1,500° to 2,000° F shown in figure 3.

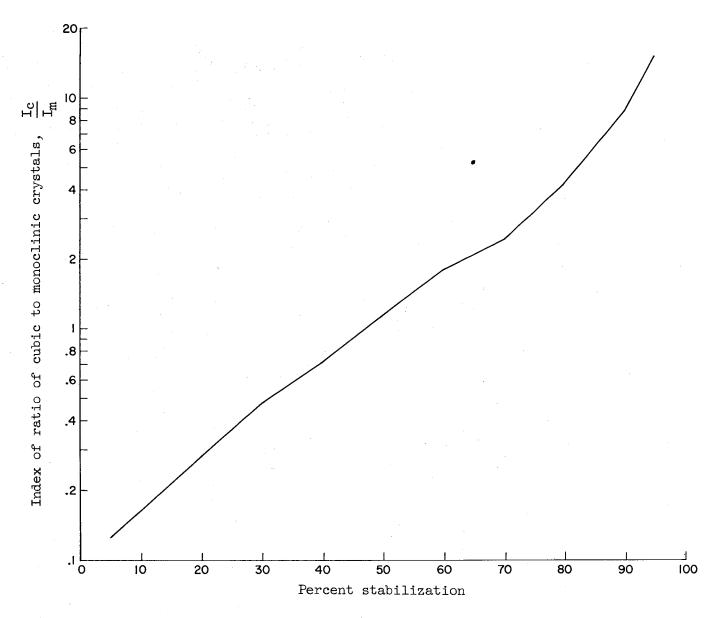
Figure 5.- Stabilization of zirconia as a function of crystalline structure.

Completely stabilized zirconia has a 100-percent cubic crystal structure, whereas partially stabilized material contains both cubic and monoclinic crystals. The ratio of the cubic to the monoclinic phase is used as the measure of stabilization. The manufacturer supplied a graph (fig. 5) showing the relationship between the degree of stabilization and the ratio of the X-ray diffraction intensities of cubic and monoclinic zirconia.

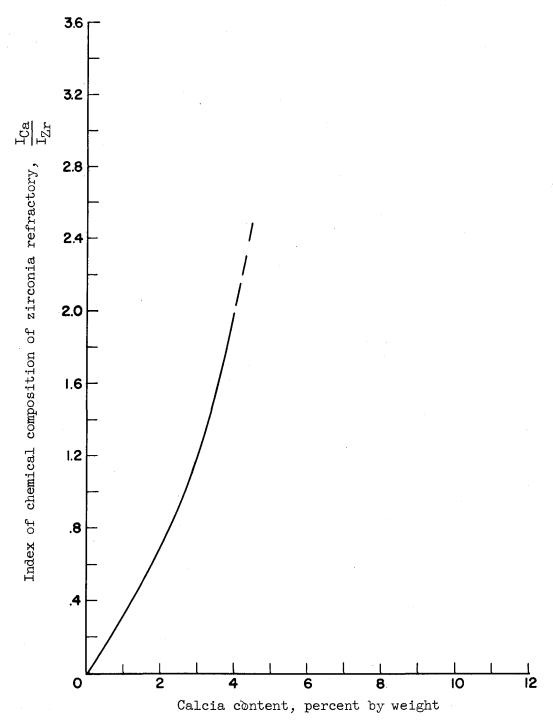
Figure 6.- Calibration curve for analysis of calcia content by X-ray examination.

Samples of unused zirconia brick were examined with X-rays before and after leaching with dilute hydrochloric acid. The acid was used to remove all free calcia, leaving only the calcia that was in solid solution with zirconia. This procedure was used to set a standard in this investigation, to show more specifically the calcia required in solid solution with zirconia to produce a given percent stabilization. The data obtained from this X-ray analysis were correlated with information obtained by a wet chemical analysis of the same materials (performed by the manufacturer), and a calcia calibration curve was constructed (fig. 6).

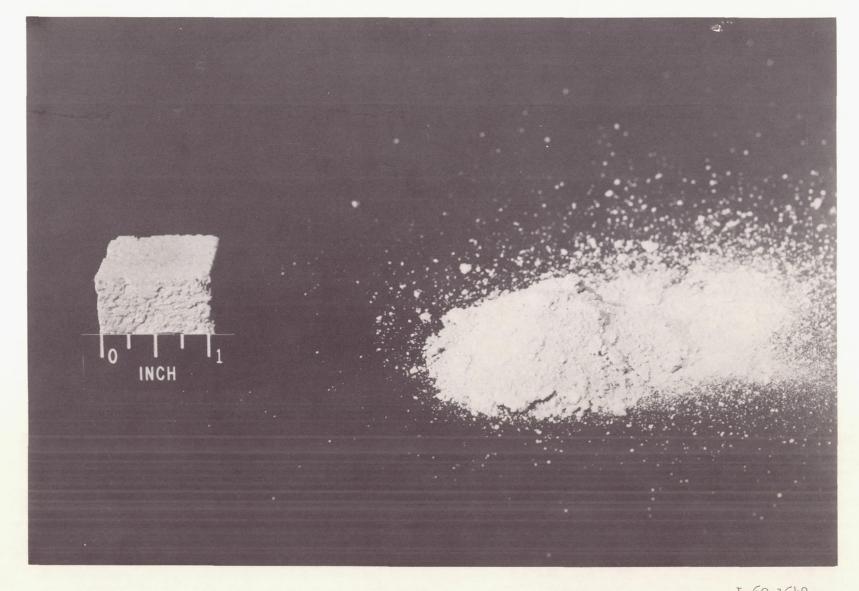
The material exposed to cyclic heat in the laboratory electric furnace resembled the deteriorated material removed from the heat exchangers. One-inch cubes of stabilized zirconia, with a compressive strength of about 3,500 pounds per square inch before cycling, collapsed while being removed from the furnace (fig. 7). Three-eighths-inch zirconia pebbles cycled in the same kiln lost two-thirds of their original strength (fig. 8).

L-62-1648
Figure 7.- A one-inch cube of stabilized zirconia before and after cycling in the laboratory furnace.

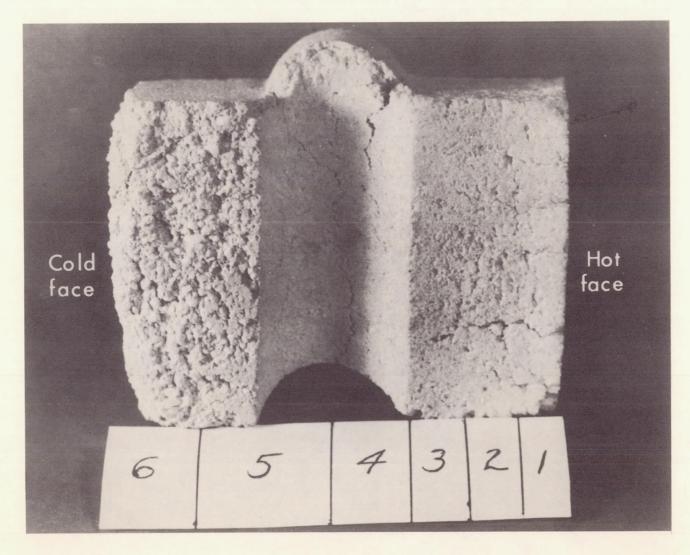
The first deteriorated zirconia sample analyzed was friable material taken from the cold face of a brick located in the refractory liner of the hot zone (area A, fig. 2). The zirconia was graded by putting a given weight of deteriorated material on a set of sieves and screening for 1 hour. Then the material was analyzed with X-rays to investigate the variances due to grain size. The finest grain sample was leached by the method described in the preceding paragraph and analyzed to determine the state of the calcia.

The high calcia content of the deteriorated face of the brick taken from the hot zone led to the investigation of the entire brick (fig. 9(a)). An X-ray examination of the entire brick showed a definite decrease in stabilization,

(a) From hot zone (area A of fig. 2). L-61-93

Figure 9.- Calcia-stabilized zirconia brick after use in the ceramic heat exchanger.

To establish more firmly the effect of temperature, a zirconia brick with deteriorated zones was restabilized by heat treatment at 3,000° F for 2 hours in a gas-fired kiln. This heat treatment caused the material to regain the color and hardness of unused stabilized zirconia. The increase in the amount of cubic phase after heat treatment, as observed by use of X-ray analysis (table IV), indicated that free calcia moved into the zirconia lattice and reestablished the calcia-zirconia solid solution.

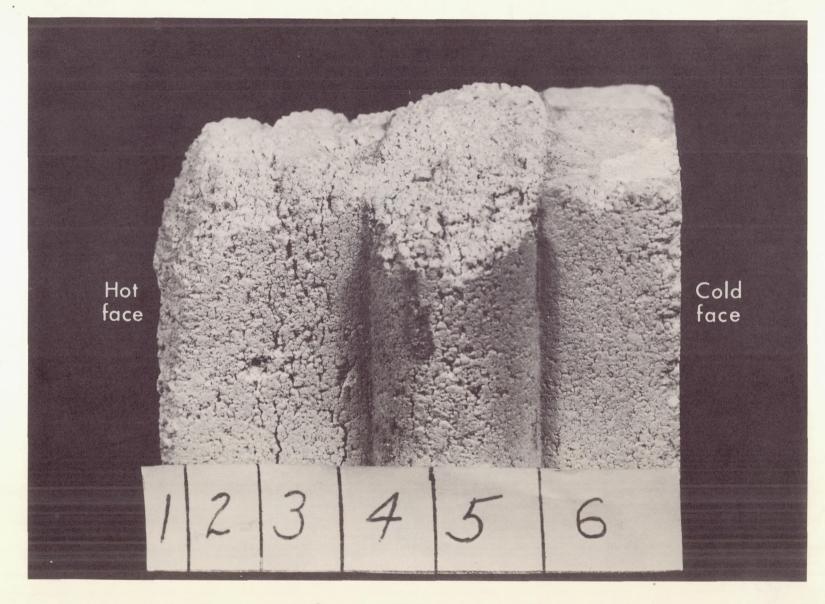
The brick shown in figure 9(b) was taken from the $1,600^{\circ}$ to $2,100^{\circ}$ F zone (area B, fig. 2) and analyzed for comparison with the brick taken from the hot zone. Although the two bricks were similar in appearance, the brick from the $1,600^{\circ}$ to $2,100^{\circ}$ F zone showed a greater degree of overall destabilization (table III). The more extensive destabilization of this brick is attributed to the fact that the local temperatures in this lower zone of the heater generally remain near the critical $(1,500^{\circ}$ to $2,100^{\circ}$ F) range for all heater firings. Thus a wider band of deterioration is produced.

(b) From zone of $1,600^{\circ}$ to $2,100^{\circ}$ F (area B of fig. 2). L-61-2154 Figure 9.- Concluded.
